Final Report

Foundation Stabilization Research Studies on a Foundation on ice poor Permafrost in Fairbanks, Alaska

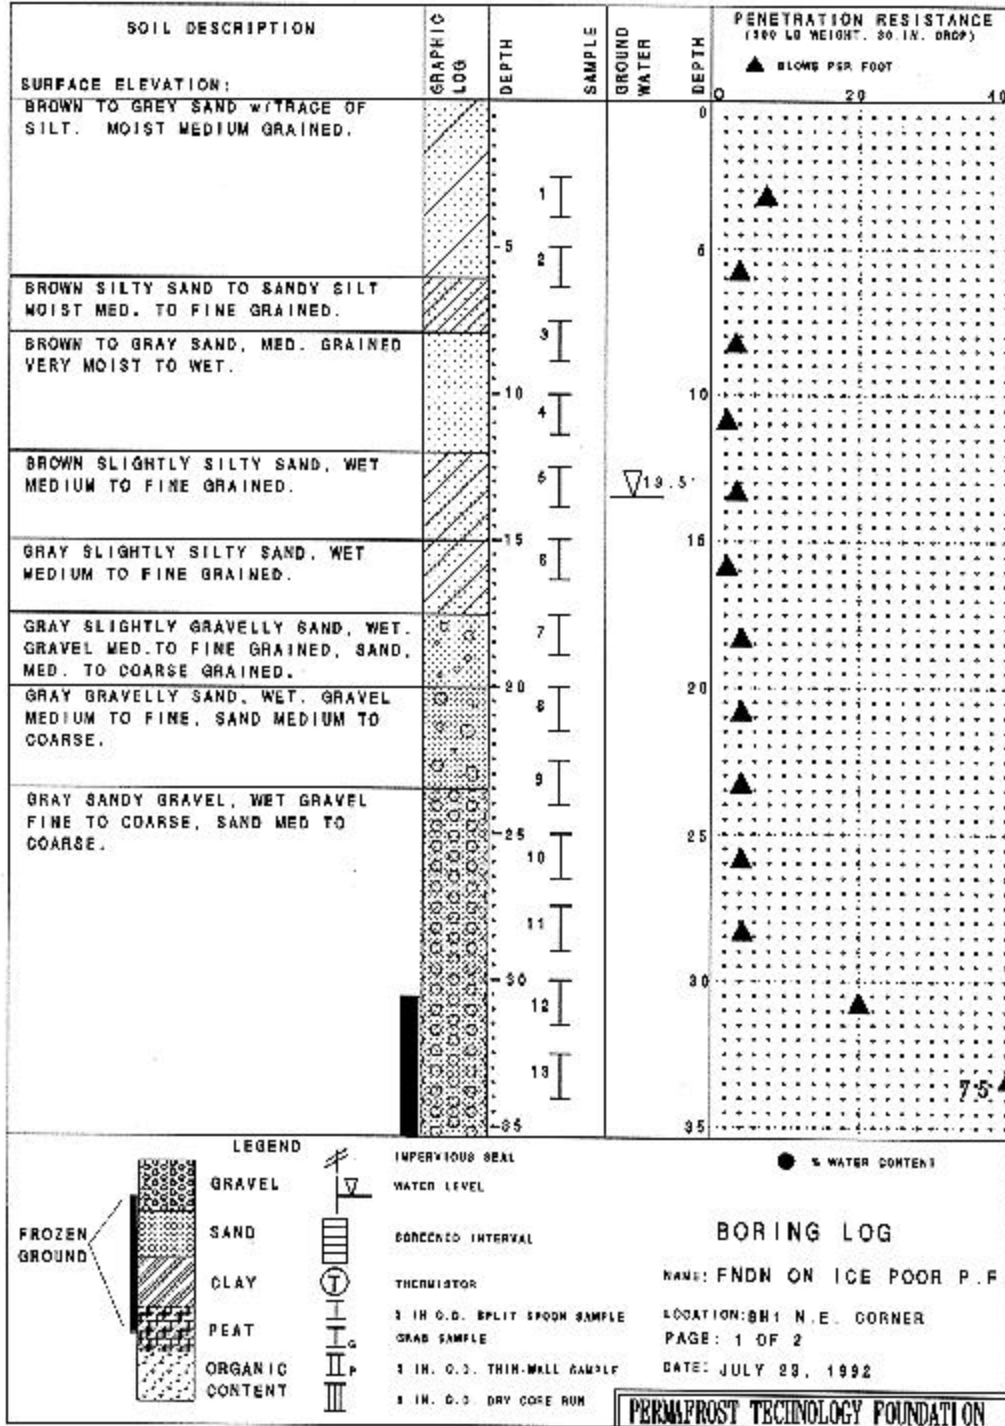
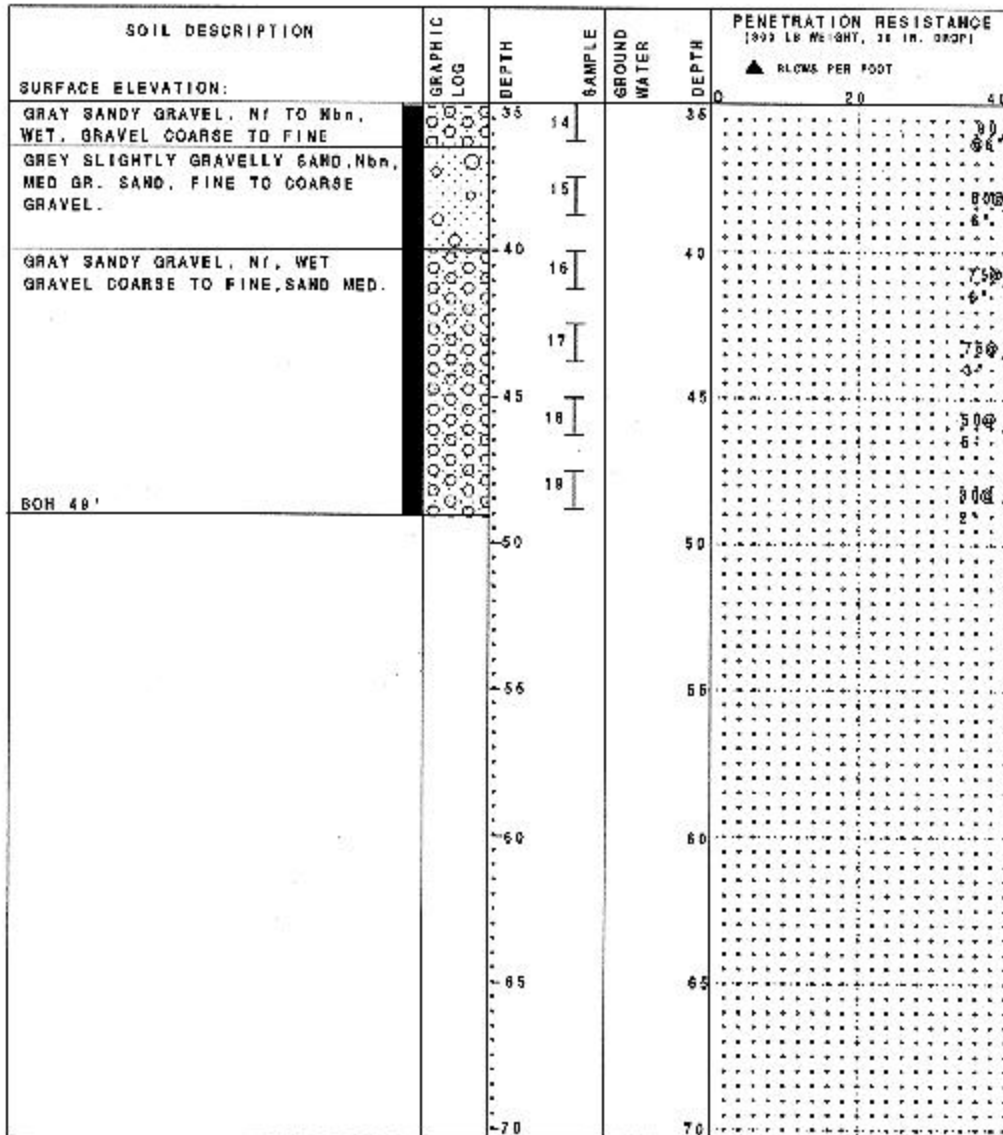
BORING LOG

In the beginning of the project, the Permafrost Technology Foundation was not aware of the original engineering reports on the house by Stutzman Engineering (they were not transferred to PTF). Therefore, when PTF received the house another permafrost exploration hole was drilled. This hole was located near the northeast corner of the house, and it discovered permafrost at 30.5 feet. The hole was drilled into the permafrost to a depth of 49 feet.

NAME: FNDN ON ICE POOR P.F.
LOCATION: BH1-N.E. CORNER (CONT)
PAGE: TWO OF TWO
DATE: JULY 23, 1992
