# Embankment evolution of a gravel road on permafrost terrain five years after construction: The Inuvik-Tuktoyaktuk Highway

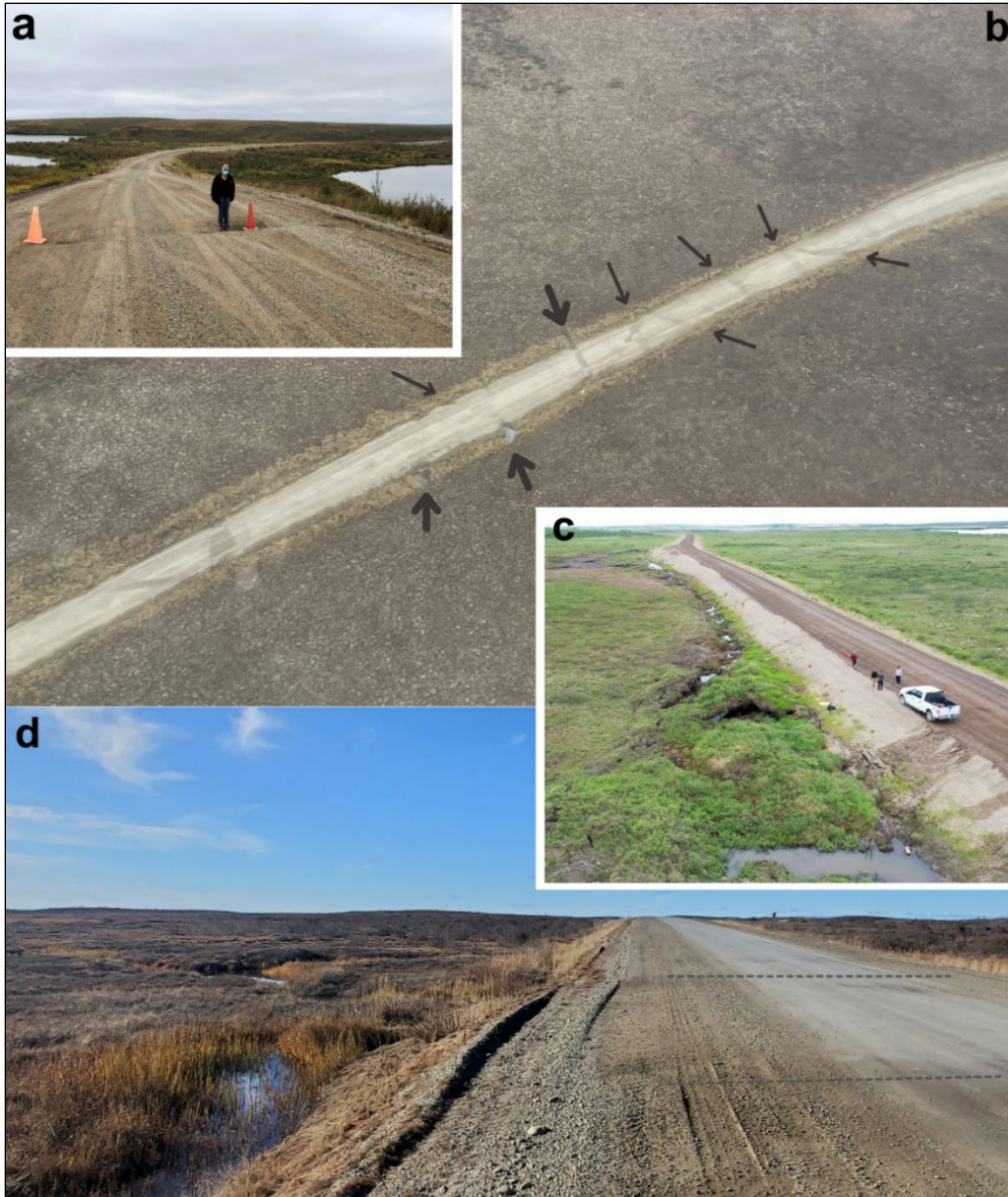
Figure 1. ITH right of way and road surface disturbances. (a) km 100: A linear depression and sinkhole caused by ice wedge thaw and surface subsidence. (b) km 46: An aerial view of ice wedge subsidence beneath the highway embankment, with the thin arrows indicating degraded troughs and thick arrows indicating degraded troughs with ponds at the embankment edge. (c) km 106: Ponding, embankment sloughing, degrading ice wedges, and a heaved mat of organic materials from a large icing and frost blister that developed in the winter 2020/21. (d) km 94: Ice wedges beneath the road expressed as subtle linear depressions, indicated by grey dashed lines, and associated degradation and ponding of ice wedges adjacent to the road. Photos by GNWT – Jurjen van der Sluijs, August 2022 (a), Aurora College – Celtie Ferguson, September 2023 (b), and June 2021 (c), and Aurora College – Jen Humphries, September 2023 (d).

along the embankment edge, the thermal and physical conditions characterizing the ITH embankment can be expected to continue evolving with implications for road performance and maintenance (Figure 1).

An observational survey of thaw-induced hazards on and adjacent to the ITH was conducted in September 2022. The survey identified 57 locations where roadbed subsidence indicated the degradation of an underlying ice wedge (Figures 2a,b,d, and 5). Most of these occurrences were north of km 40, and were clustered on tundra uplands between Trail Valley and Hans Creeks (km 40 to km 55)—where the embankment was constructed to a reduced height—and in low-lying lacustrine plains with extensive polygonal peatlands between about km 80 and km 115. Although ice wedges are large and abundant near Tuktoyaktuk, there was only one observation of ice-wedge thaw directly affecting the northernmost portion of the ITH, constructed overtop of the pit 177 access road established in 2013. Within the context of these regional patterns, the highest density of ice-wedge subsidence expressed at the road surface (0.7 km<sup>-1</sup>) was associated with embankments < 0.5 m thickness, and the lowest density (0.14 km<sup>-1</sup>) was associated with embankments greater than 1.5 m thick.

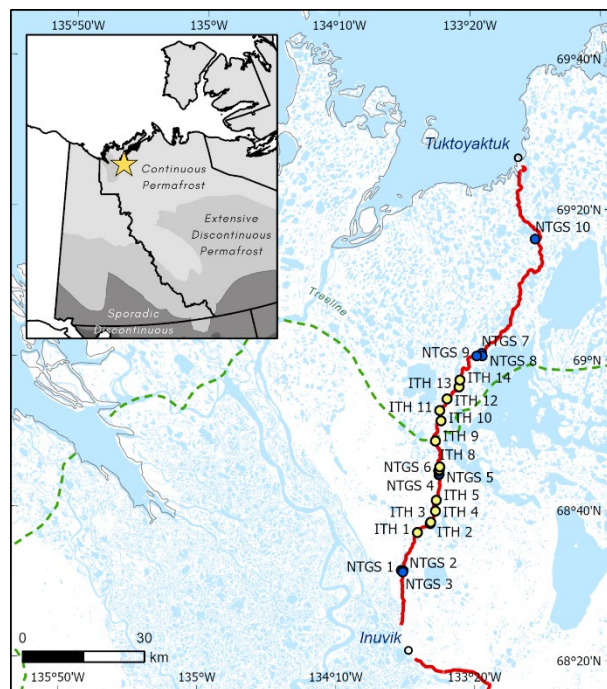
Figure 2. The ITH corridor and locations of the 23 ground temperature monitoring sites. This includes 10 “Sentinel” sites in natural environments, and 13 “Embankment” sites distributed across treeline (dashed green line) from 14 to 81 km north on the ITH. NTGS 10 is a tundra hilltop at km 120.

The ITH forms a 137 km corridor across the forest-tundra transition zone and is underlain by ice-rich permafrost (Figure 2; Burn and Kokelj 2009). Cooler and drier conditions near the coast and warmer and wetter conditions inland are accompanied by the transition from shrub tundra to taiga forest (Lantz et al. 2013). A northward decrease in ground temperatures is associated with lower thaw season temperatures and thinner snow cover towards the coast (Kokelj et al. 2017).

Sentinel network comprises undisturbed hilltop, peatland, and riparian environments as well as borrow pits along the ITH corridor, while the ITH Embankment sites include boreholes through a range of embankment thicknesses from km 23 to 120 (Figure 2). The Sentinel sites analyzed in this paper (Table 1) are in undisturbed tundra ranging from 40 to 360 m away from the ITH. The 14 ITH Embankment sites were instrumented in 2017, each with a single ground temperature cable (GTC). One site, ITH 3, was destroyed early on so only 13 sites were used for the analysis (Table 1). Boreholes were drilled through the embankment and a minimum of 2 m into the native soil. GTCs were installed vertically through the embankment, and horizontally along a shallow trench to the shoulder of the road. Only the centreline data was used for this study. The total borehole depths of the GTCs ranged from 3.0 to 6.7 m. Each Embankment GTC consisted of 13 YSI #44007 thermistor beads and a Lakewood RX16 data logger. Full details on the installation of ITH Embankment sites and ground temperature data are available in Rudy et al. (2020a,b).

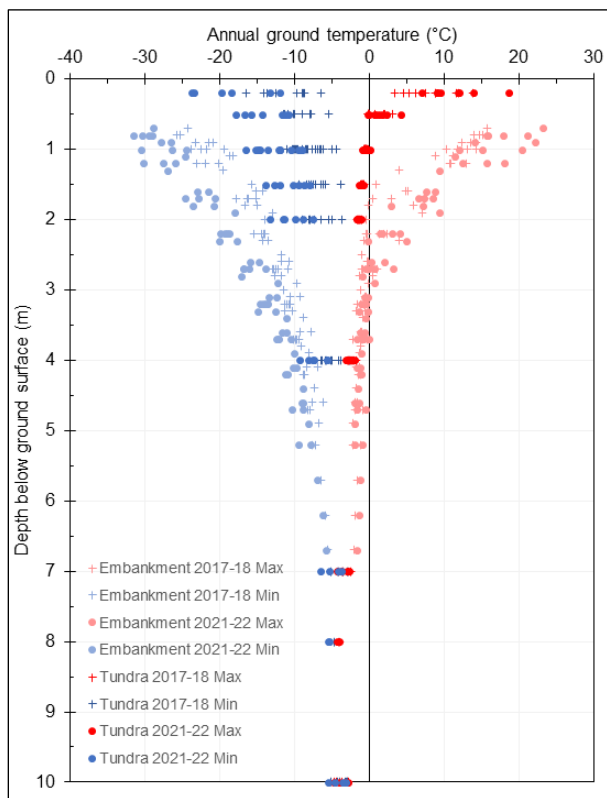
Figure 3. Ground temperature envelopes for 2017–18 and 2021–22, showing maximum and minimum daily temperatures with depth. Shaded colours are the embankment sites (ITH 1–2, 4–14), and solid colours are the tundra sites (NTGS 1–10). Depths for embankment sites are relative to the road surface at the time of installation in March 2017.

Ground temperature envelopes show that embankment sites have a much greater near-surface seasonal temperature variation than undisturbed tundra (Figure 3), due to the contrasting material properties and ground surface conditions (vegetation and snow) between the road embankment and natural tundra environment. In undisturbed tundra, minimum winter temperatures at 1.0 m depth ranged from -9.0°C to -16.6°C in 2021–22. At comparable depths below the centreline of the snow-free

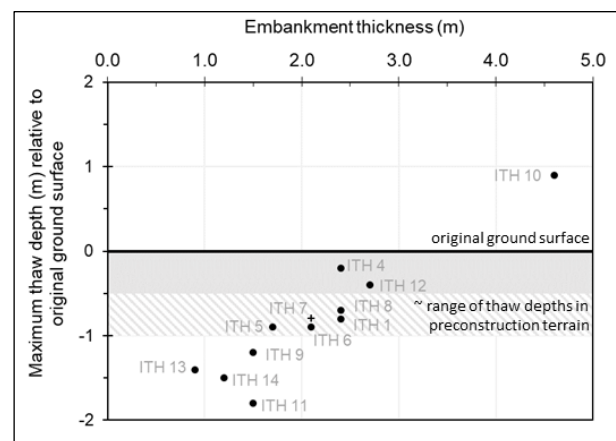
Figure 4. Estimated thaw depths at embankment sites relative to the original ground surface (i.e., native ground) against constructed embankment fill thickness in 2017. The grey box represents the preconstruction active layer zone and the hatched area approximates the position of the permafrost table in preconstruction terrain. Black dots indicate thaw depths from 2021–22; + indicate data from 2020–21.

There is an inverse relationship between embankment thickness and thawing of the underlying native ground inferred from the temperature data at the 10 ITH boreholes

(Figure 4). Assuming (1) the maximum active layer thickness in the original terrain that the highway was built over was between 0.5 and 1.0 m (Table 2), and (2) considering the thermistor depths relative to the original ground surface, we can estimate whether permafrost has aggraded or degraded under different embankment thicknesses (Figure 4). Maximum thaw depths relative to the 2017 embankment thicknesses at the 13 sites suggests that in all but one deep-fill embankment site, thaw depths in 2022 reach below the original ground surface. This is confirmed by the shallowest thermistor in native soils beneath the embankment which rise above 0 by end of summer 2022 for 10 out of 12 sites with available data (Table 2). The thickest embankment (4.6 m), and the greatest thaw depth (3.7 m; Table 2) were found at ITH 10; it was also the only site where thaw depth was maintained within the embankment materials above the original ground surface (Figure 4). At 7 sites with embankments between 1.5 and 2.7 m maximum thaw depths were estimated to be within the active layer of the preconstruction terrain (Figure 4). At 4 sites with embankment thicknesses of less than 1.5 m, the thaw depths exceed the thickness of the road embankment and the original active layer resulting in some permafrost degradation.

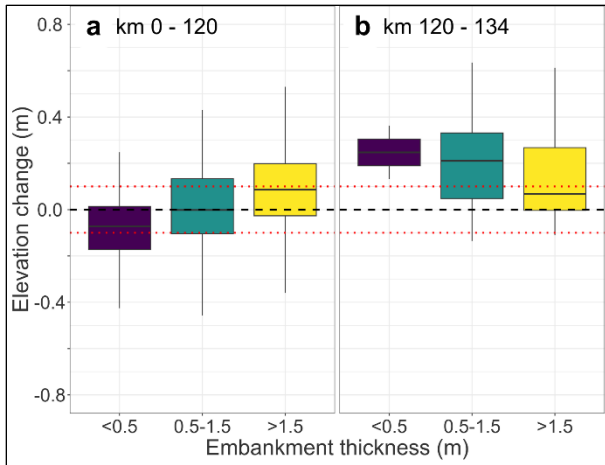
Figure 6. Box and whisker plots showing the net change in elevation of the road surface edge between August 2019 and August 2021, sampled at 100 m intervals along the ITH. Relative change stratified by embankment thickness is shown for (a) km 0 to km 120, and (b) km 120 to km 134. Red dashed line represents estimated level of uncertainty (10 cm) inferred from averaged standard deviation of elevations between the two DEMs at locations away from the road surface.

Estimated road surface subsidence from the period August 2019 to August 2021 corroborates these patterns. Figure 6a shows that the thinnest embankments (< 0.5 m) experienced the greatest amounts of subsidence between 2019 and 2021, and those greater than 1.5 m thickness experienced little to no net elevation change (Figure 6). This pattern, in conjunction with evidence of ice-wedge thaw subsidence that was often associated with < 0.5 m embankments, supports the idea that ice-rich permafrost is thawing beneath the thinnest embankments (Figure 5), and that permafrost has either not thawed, or aggraded, beneath embankments that remain greater than 1.5 m thick. In stark contrast, net surface subsidence was not detected by this analysis for the northernmost section of the ITH, constructed over the pit 177 access road, regardless of embankment thickness.
