# Permafrost protection by thermosyphon under the paved road in West Mongolia

Jambaljav Yamkhin<sup>1</sup>, Namdag Choibalsan<sup>2</sup>, Tsogt-Erdene Gansukh<sup>3</sup> & Ulambayar Ganbold<sup>3</sup>

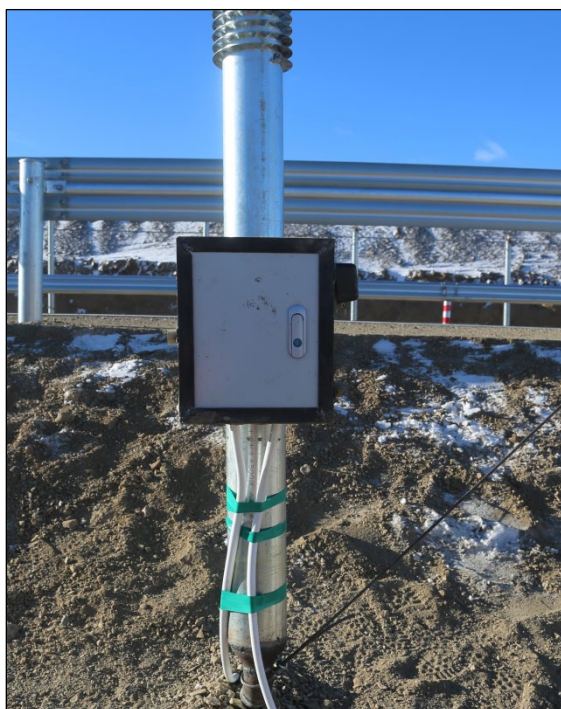
Under paved roads, inclined holes were drilled at an angle of 30 degrees with a distance of 3 m between them, into which iron pipes with a diameter of 50 mm (thermosyphon evaporators) and a PVC tube with a diameter of 15 mm were inserted. Some 15 mm PVC tubes have thermistors and data loggers to monitor the temperature under the paved road (Figure 4).

Figure 4. Monitoring box: temperature sensors are installed in white PVC tubes at the end of the evaporator tube and between the thermosyphons.
