# Long-term evaluation of mitigation techniques used for permafrost thermal stabilization at the Beaver Creek (YT) experimental road site

Ximena López, Jean-Pascal Bilodeau, Guy Doré & Chantal Lemieux  
*Université Laval and Centre for Northern Studies, Québec City, Québec, Canada*

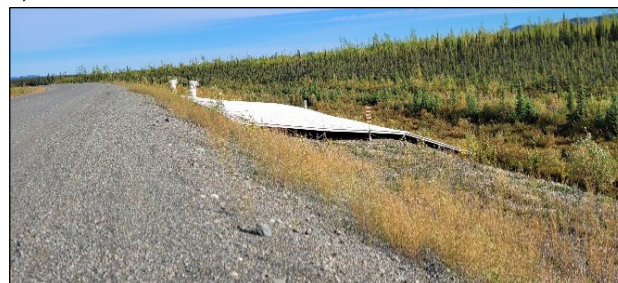
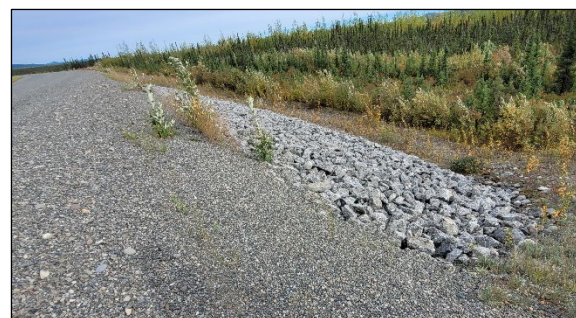
Figure 6. The snow/sun shed (a) and ACE uncovered (b) sections in 2023.

The analysis of temperature data at the Beaver Creek Experimental Road Site provides valuable insights into the long-term performance of permafrost mitigation techniques. Over a decade of observation, promising performance in some slope protection techniques is observed, such as the ACE uncovered (section 9) and the snow/sun shed (section 6). Indeed, these two sections have shown the best embankment conditions after 15 years, during a site visit in 2023 (Figure 6).
